How Did Apollo 11's Lunar Module Land on the Moon?

(Or, "A Nominal Lunar Landing Flight Profile")

Apollo 13: What Happened? (1 of 4)

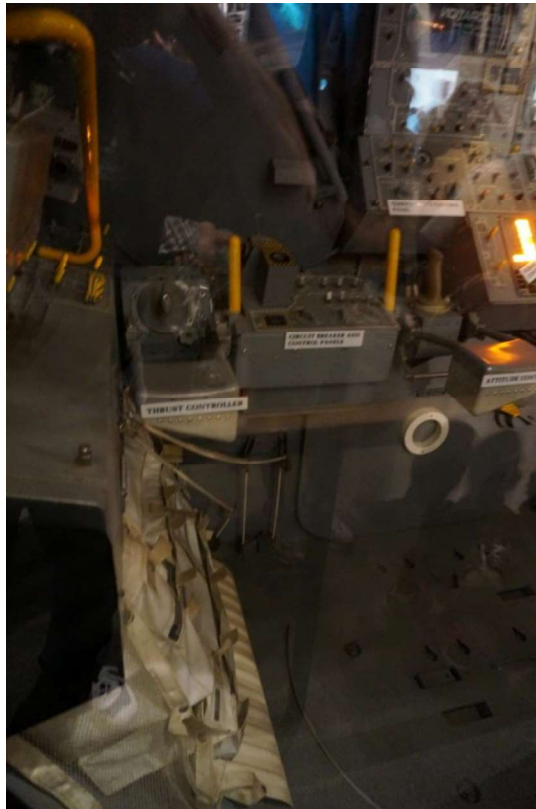
LM Interior, Commander's Control Station (Port Side of Cabin)
[Note Hand Controller for Thrust (left) and Attitude "Joystick" (right).] [NASM]

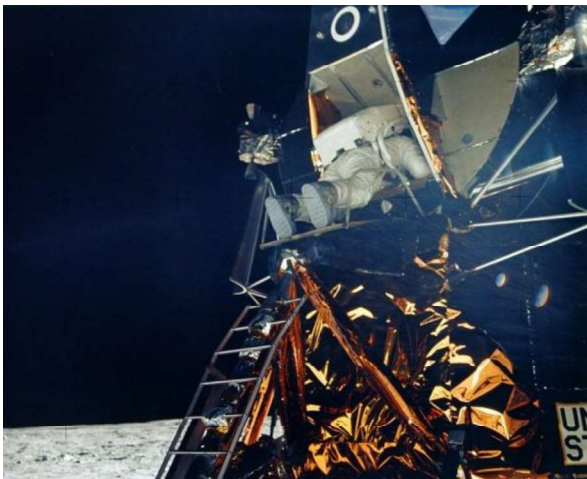
LMP “Buzz” Aldrin’s Egress from “Eagle”
on the Sea of Tranquility
(July 20, 1969)

[Note Personal Life Support System, known as the “PLSS” backpack.]

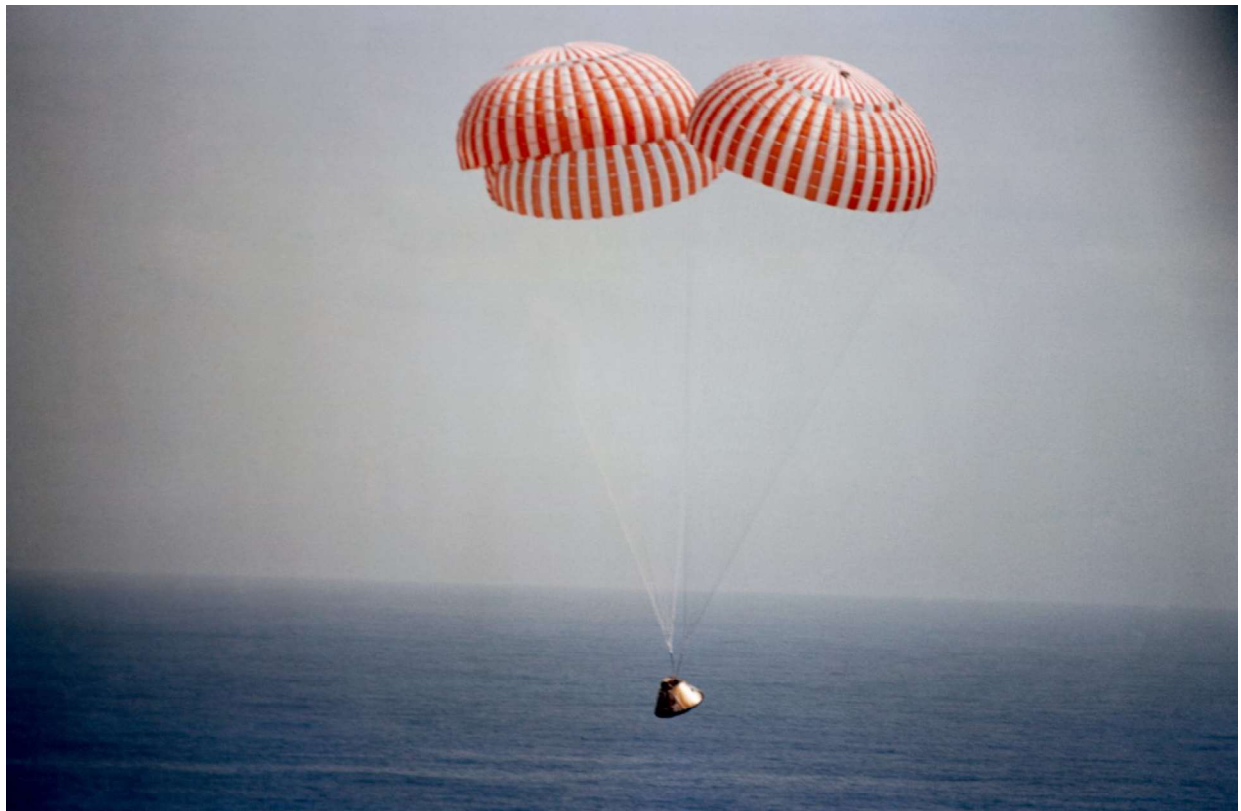
Apollo 9 Command Module “On the Mains” After Re-entry
(Note 27.5 degree angle of suspension for CM “Gumdrop”.)

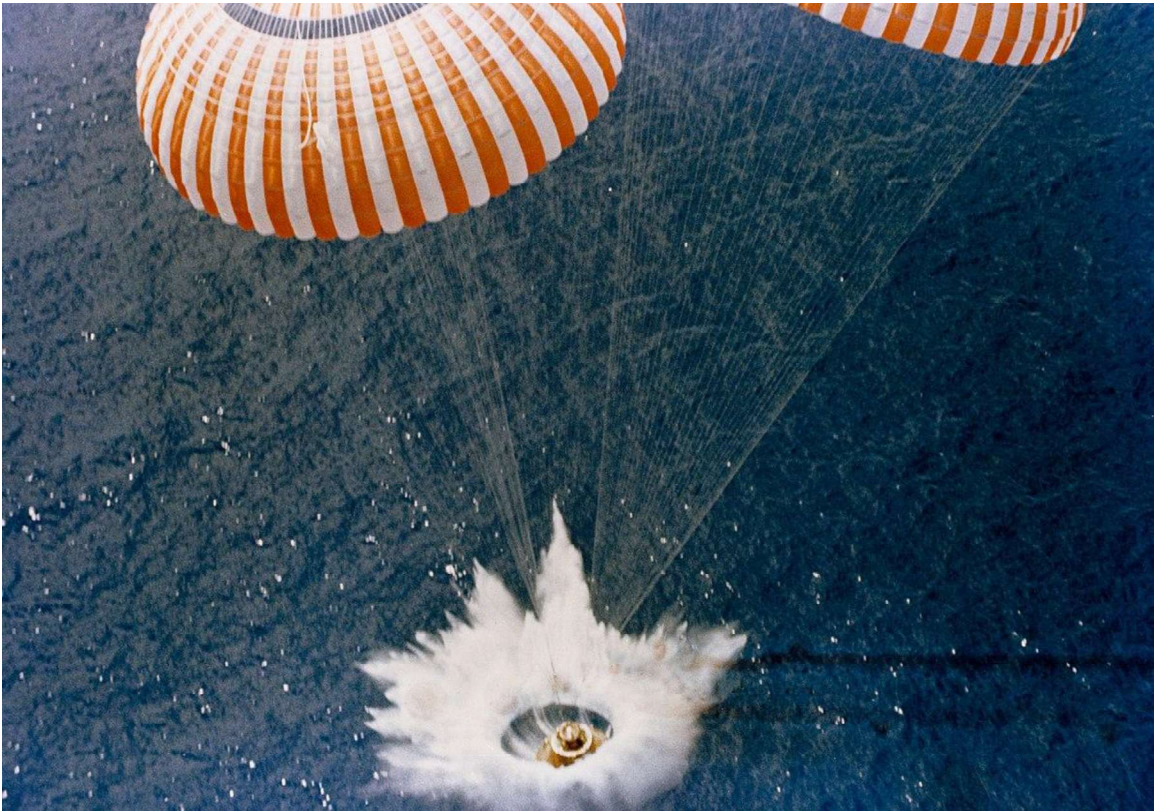
**...Resulting in Some Additional Drama at the Moment of
Splashdown**
(Note the extremely hard water entry.)

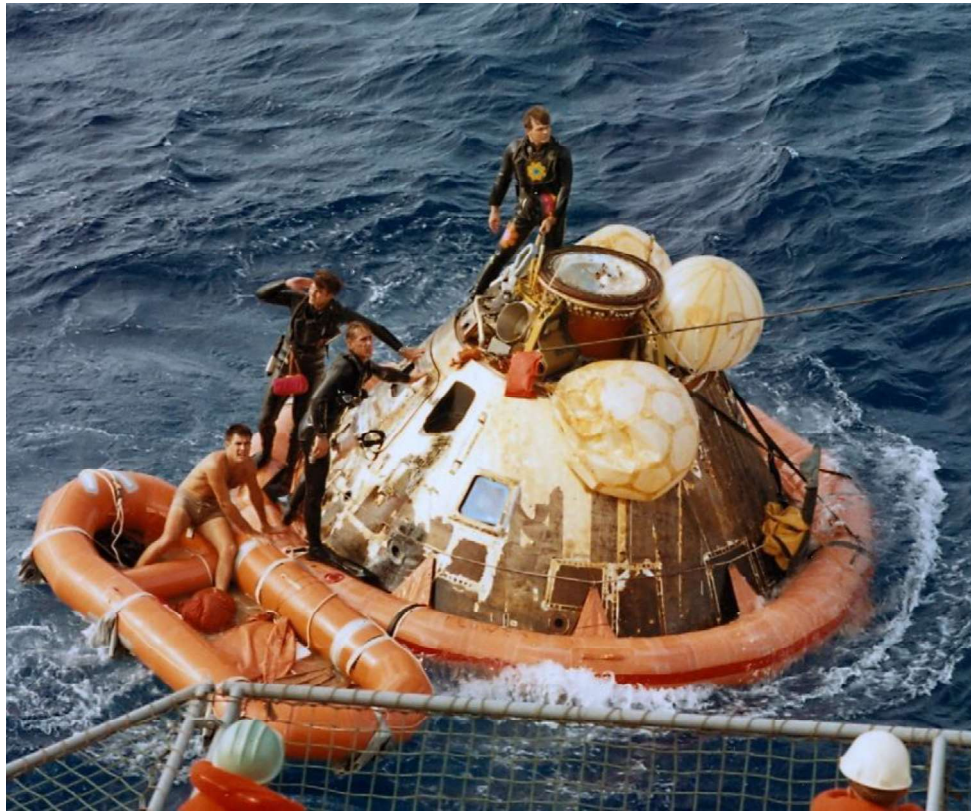
Shipboard Recovery Commences for Apollo 11 Command Module “Columbia”

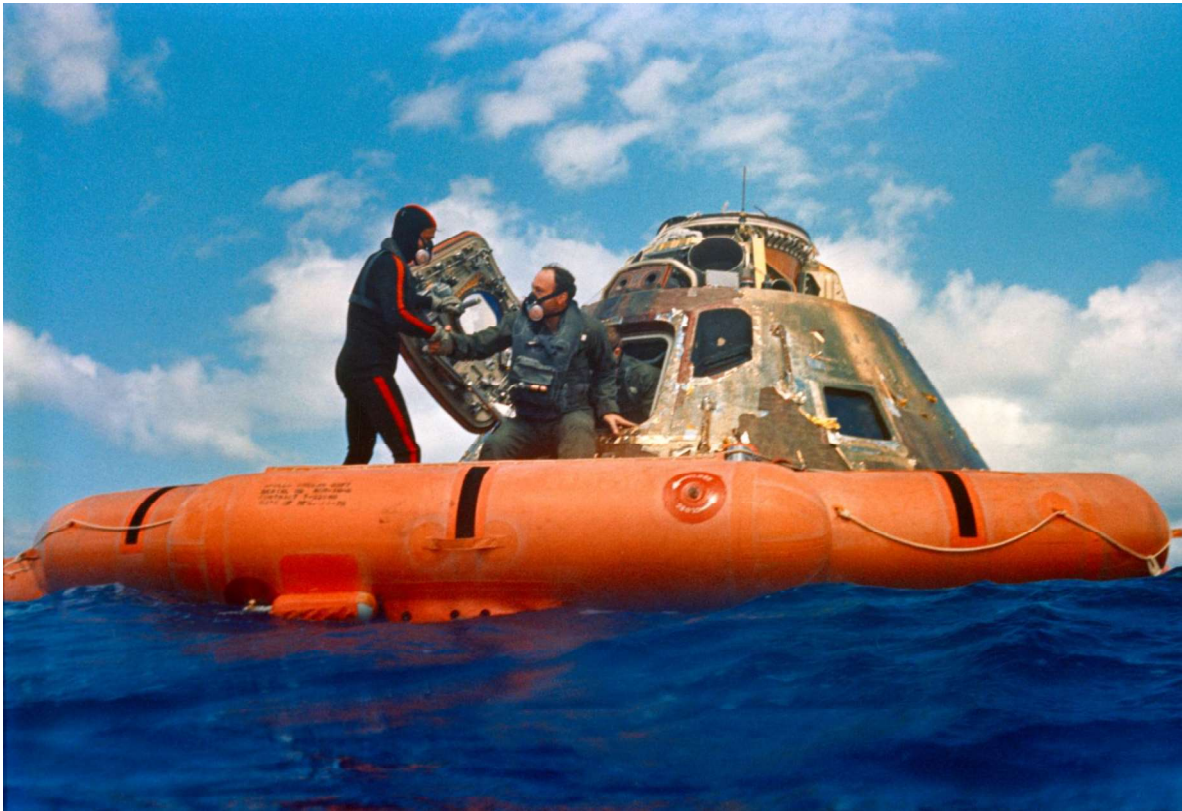
**Lunar Module Pilot Ed Mitchell Exits
Apollo 14 Command Module “Kitty Hawk”**

(The Navy’s splashdown recovery team was on the scene so quickly that the crew chose not to deploy the flotation bags.)

- Normally, the 3 air bags were inflated following splashdown regardless of whether or not the Command Module was upside down; in one case---Apollo 14---the Navy’s splashdown recovery team arrived so quickly that the 3 air bags were not deployed.

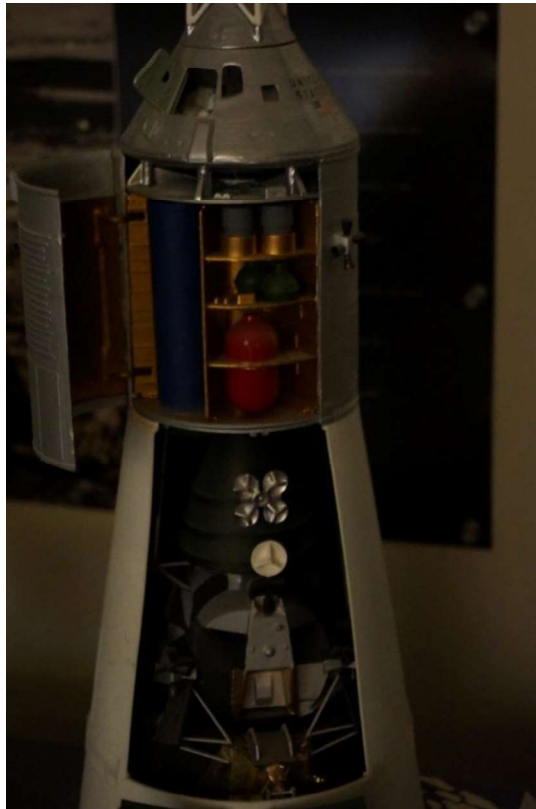
Another View of the Service Module's 2 Oxygen Tanks (Green in Model);
The 3 Fuel Cells Above Them Are Grey, and the 2 Hydrogen Tanks Below
Them Are Red
